DEPARTMENT OF TRANSPORTATION**DIVISION OF ENGINEERING SERVICES**

Contract #: 04-0120F4Cty: SF/ALA Rte: 80 PM: 13.2/13.9File #: 69.28**WELDING INSPECTION REPORT****Resident Engineer:**Pursell, Gary**Address:** 333 Burma Road**City:** Oakland, CA 94607**Report No:** WIR-002968**Date Inspected:** 20-Jun-2008**Project Name:** SAS Superstructure**OSM Arrival Time:** 630**Prime Contractor:** American Bridge/Fluor Enterprises, a JV**OSM Departure Time:** 1530**Contractor:** Zhenhua Port Machinery Company, Ltd (ZPMC), Changxing Island **Location:** Shanghai, China

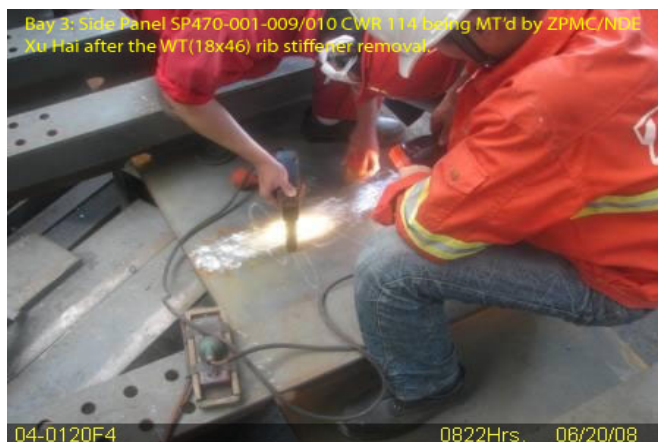
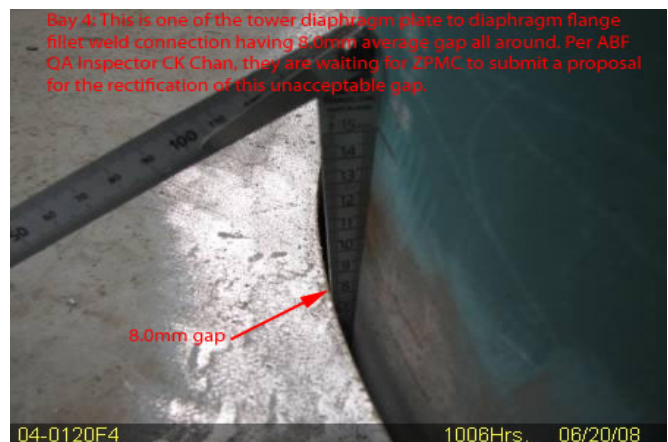
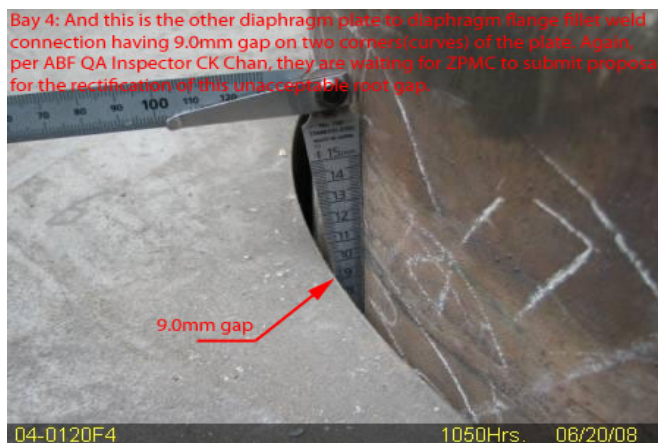
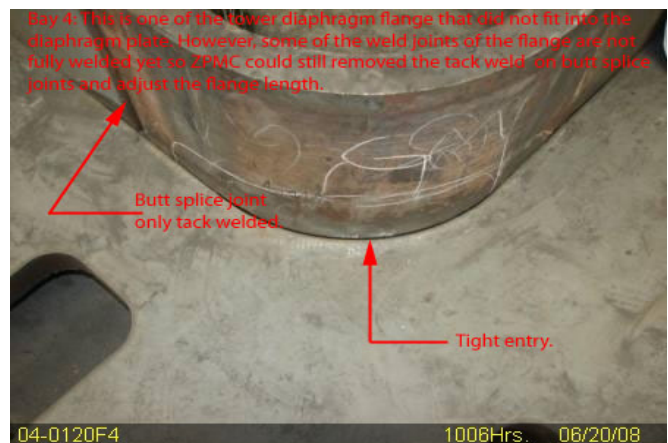
This QA observed three tower diaphragm flanges were having issues fitting to diaphragm plates. One flange marked NSD1-SA335 was having problem getting into (inside) the plate though three of the welds of this flange are only tack welded, ZPMC could still adjust the inside length of the flange. The other flange marked SA286 was having 8.0mm root gap almost all around the diaphragm plate. The third flange marked SSD1-SA335 has two sides (curves) of the diaphragm plate having 9.0mm root gap. Per ABF QA Inspector CK Chan, they are waiting for ZPMC proposal for the rectification of this unacceptable flange gap and not to fit flange into the plate. See photo below.
